1. CASE NO. 941115CCC3078 H94A0250		2. INVESTIGATOR'S ID [8][3][1][0]		3. OFFICE CODE [8][7][1]		EPIDEMIOLOGIC INVESTIGATION REPORT	
4. DATE OF INCIDENT YR MO DAY [9][4][1][0][2][1]		5. DATE INVESTIGATION INITIATED YR MO DAY [9][5][0][1][0][5]

6. SYNOPSIS OF INCIDENT OR COMPLAINT A residence fire was determined to have been caused by a toaster oven that overheated. Examination by an electrical engineer found that a part of the oven failed allowing the oven to continue heating. Noone was injured.							
LOCATION (Home, school, etc.) Home [10]		8. CITY Carlsbad			9. STATE CA		
10A. FIRST PRODUCT Toaster Oven [0][2][1][6]		11A. TRADE/BRAND NAME, MODEL NUMBER, MANUFACTURER & ADDRESS Black and Decker, Towson, MD TROYCO

SUBJECT: Laboratory Examination: Black & Decker Toaster Oven
Insured: La Costa Ownership Corporation
Claim #: CC 4152
Your File Number: 1094.27

The failure of the **Black & Decker Toaster Oven Thermostat** caused the unit to continuously heat. No other evidence of electrical malfunction was observed.

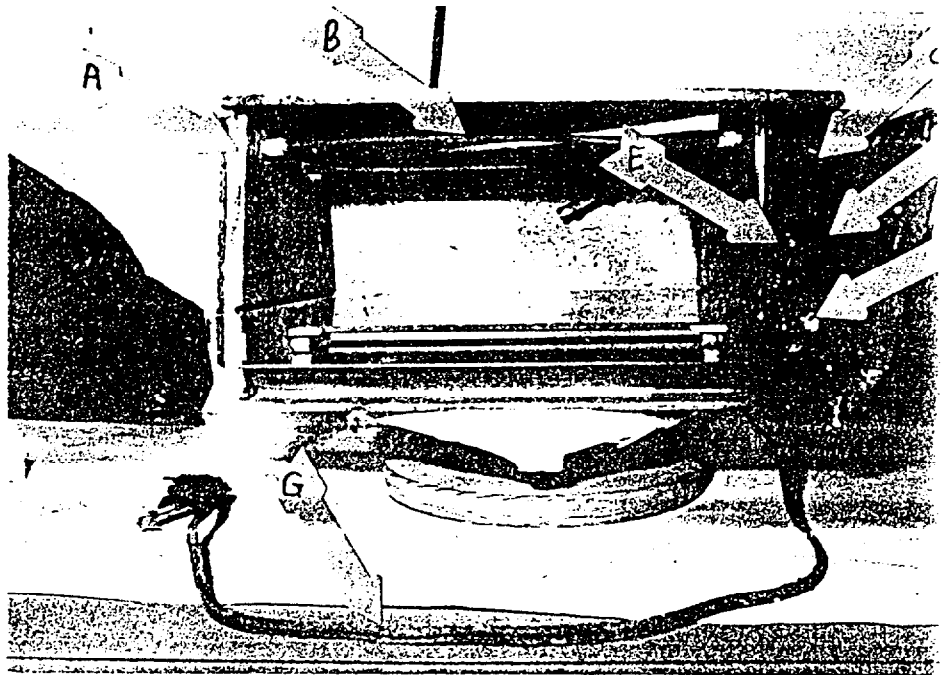
PHOTOGRAPH #1

The Black & Decker Toaster Oven. A. Arrow B indicates one of the upper heating elements; C the thermostat (Bake Control); D, the Pilot Lamp; E, the Toast Lever; F, the Toast Control; and G, the power supply cord. The Toast Control is in the OFF position.

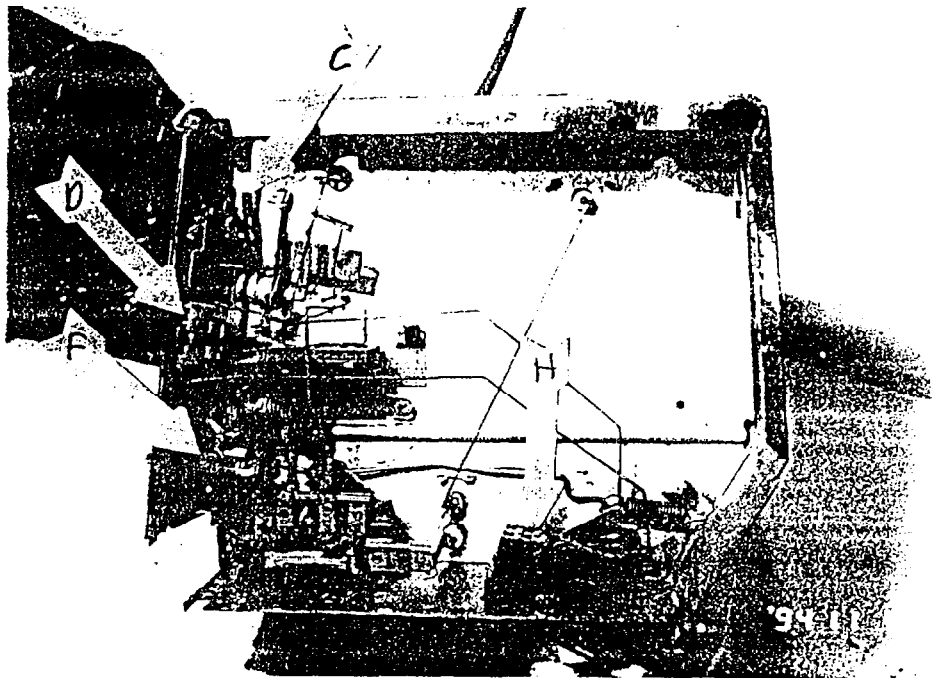
PHOTOGRAPH #3

The control end of the oven with the plastic end cover removed. Arrow C indicates the thermostat (Bake Control); D, the Pilot Lamp; F, the Toast Control; and H the Door Switch.

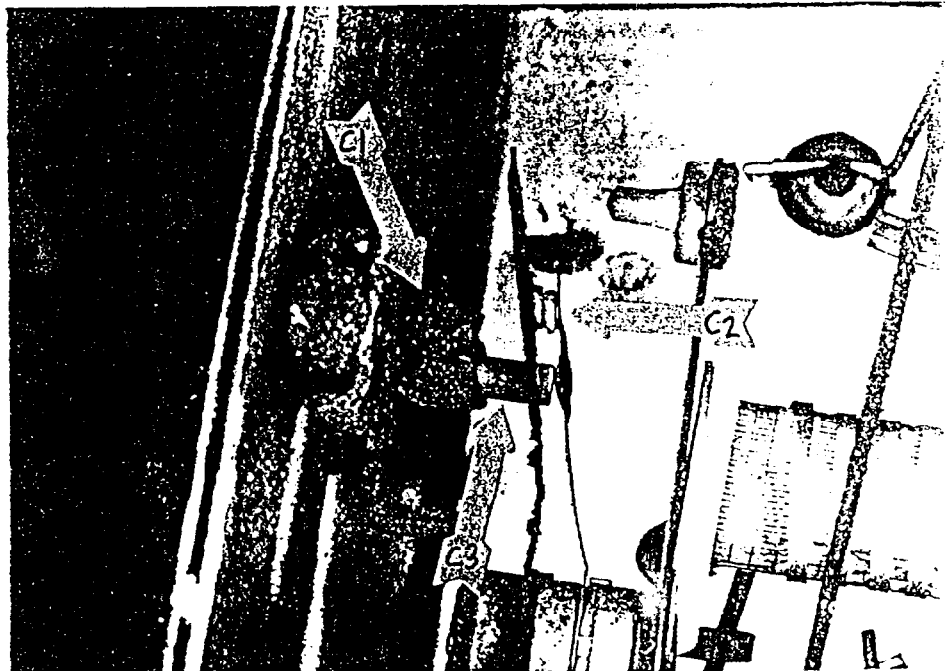
PHOTOGRAPH #4

The **Black & Decker** toaster ovens of this type have a thermostat which fails with the control contacts in the closed position. The oven will then continuously heat until the power supply is interrupted. Several toaster ovens with a similar thermostat have exhibited this problem.

1. It is my opinion based on the post fire condition of the **Black & Decker Toaster Oven** and previous experience with this type of toaster oven that failure of the thermostat (Bake Control) caused the unit to continuously heat resulting in the internal and external damage observed.

A close-up of the thermostat. Arrow C1 indicates the plastic part of the Thermostat Operating mechanism. When the operating mechanism moves forward, the control contacts, C2, close permanently energizing the heating elements. Arrow C3 indicates the ceramic pin which transfers the force to the rear moveable contact.

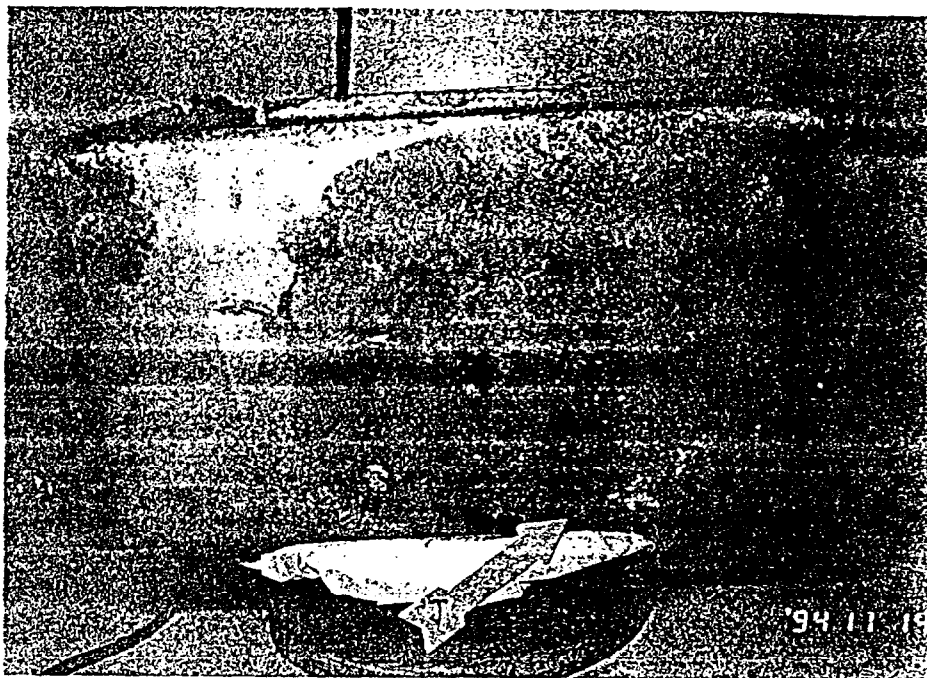
PHOTOGRAPH #7

The top of the toaster oven cabinet. Arrow J indicates a bead of melted copper deposited onto the surface.

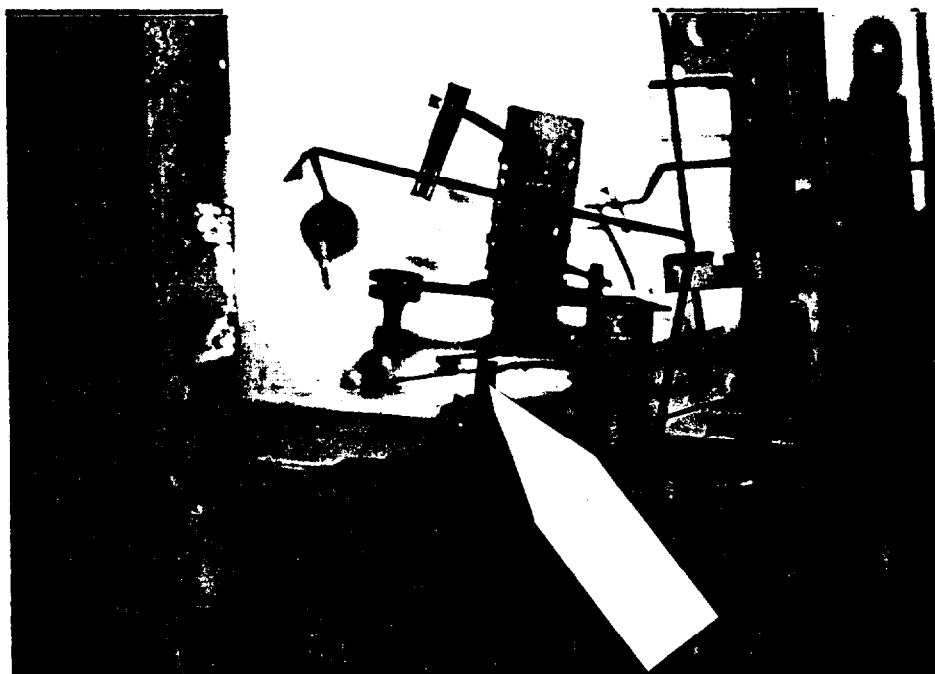
PHOTO #8 Point of failure
